# Six Overlooked Problems on the Zenith Carburetor

*It pays to pay attention to detail*

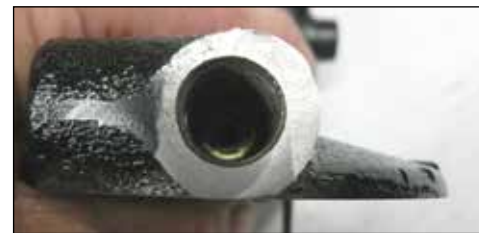
Figure 3a

If the float and float valve are removed, this will provide access to the end of the strainer hole. (See figure 3a.)

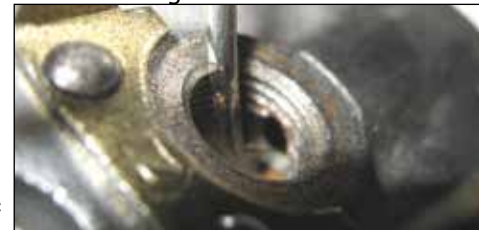
Figure 3b shows the broken end of the strainer from the float valve threaded hole.

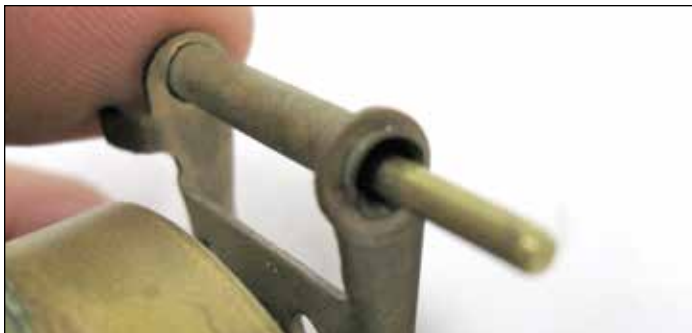
Figure 5

As a case in point, one of the carburetors I was working on had a new, reproduction float. It fit sloppily on the float pin. The original Zenith float pin has a diameter of  $\frac{3}{32}$ , .093, or #42. The foreign-made float had a diameter of  $\frac{1}{8}$ , .120, or #31, which is too large, causing the float to be sloppy on the float pin. (See figure 5.)

When purchasing Zenith reproduction parts, you are better off to purchase USA-made parts. They cost more, but are made to the original specifications.

Also, the USA-made floats are leak-tested before being shipped from the factory, so they are ready for use. (In case you wonder, the float pin is 1.355 inches long.)

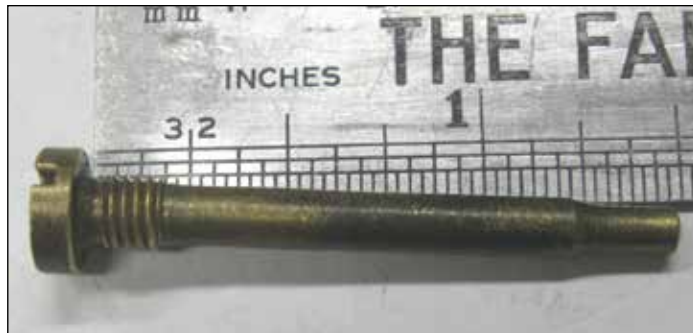
Figure 7

If using a reproduction main jet, be sure to check the length. It should measure 1.48 inches from the top of the

jet to the bottom of the threads. A lot of the reproduction jets are  $\frac{1}{16}$ " to  $\frac{1}{8}$ " too short. These need to be soldered on the non-threaded end to add length to the jet. The jet can then be redrilled to be usable.

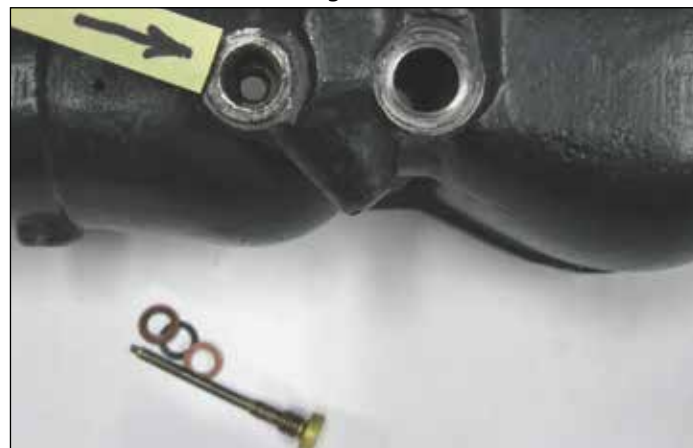
Figure 8

The main problem I have found with the main jet is old gaskets inside the lower body casting. (See figure 8.) There should be only one gasket.

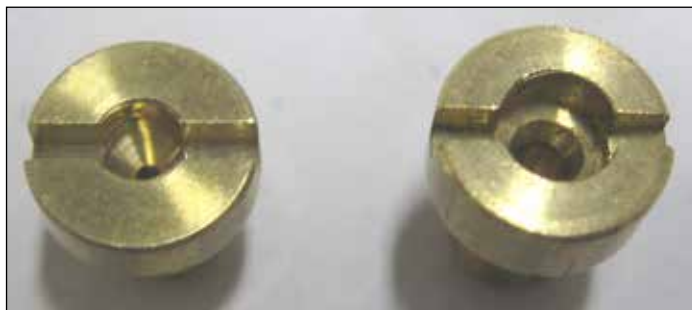
Figure 6. Compensator jet at left adjustment needle set at right.

The compensator jet fits inside the float chamber at the lower rear, left side of the lower body casting. Figure 6 shows the compensator jet A-9575 on the left and the adjustment needle seat A-9532 on the right.

All too often I find an adjustment needle seat in place of the compensator jet. They look very similar, but the adjustment needle seat has a larger diameter hole, which is also countersunk for the needle to seat into. Be sure not to use this for the compensator jet, because the adjustment needle seat will add too much gas to the air/fuel mixture.

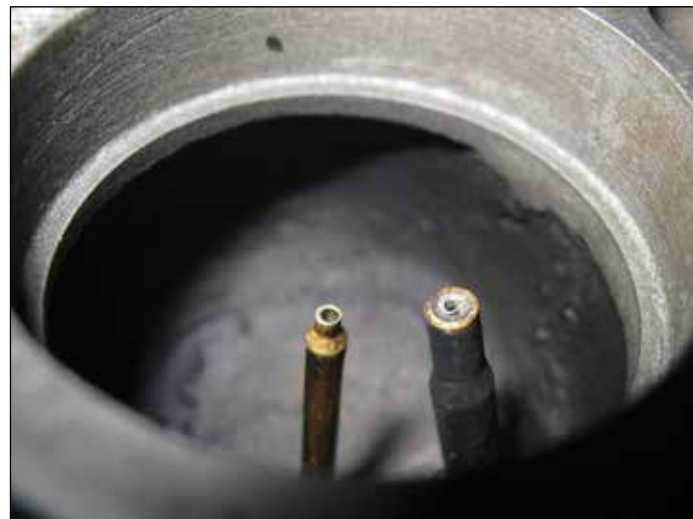
Figure 9

A main jet that is lower than the cap jet (see figure 9) will seep fuel from the float bowl. This fuel comes out of the top of the main jet and drains to the rear of the carburetor when the engine is not running. (This is another good reason to turn off the gas tank shut-off valve when not running the engine.)

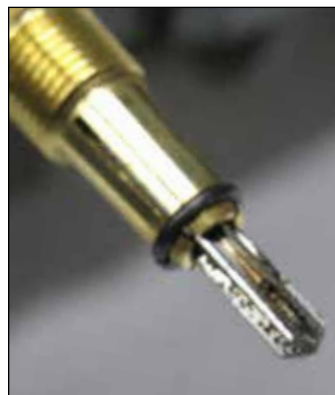
Figure 14 shows the chips on the reamer that were removed from the housing. The wrench size will be 10 mm if the adjustment housing is original or a quality reproduction. Other reproduction housings use a  $\frac{7}{16}$  inch wrench.

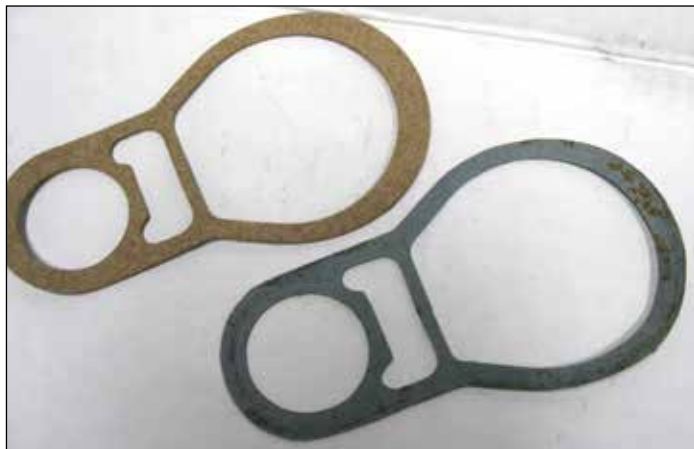
This is the gasket that fits between the carburetor's top and bottom castings. Figure 15a shows the brown gasket on the left, which is made to original specifications. Like the original gaskets, it measures  $\frac{3}{64}$  inch.

The blue gasket on the right is a paper-thin reproduction gasket. It measures  $\frac{1}{64}$  inch, almost two-thirds thinner than the original gasket. Figure 15b shows a side view of the two gaskets, showing the contrast in their thickness. To put this in perspective, it would take three blue gaskets to equal the thickness of one brown gasket.

The thick gasket is more durable, will last longer, and will also compensate for casting flaws. The thin gasket will affect the height of the idle jet (A-9542) from the lower carburetor casting, which in turn can cause idling problems.
