Fuel Leaks with Zenith Carburetors

How to fix some common problems.

By Lynn Sondena

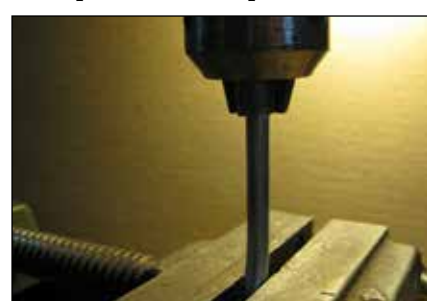
Figure 3

Then place a 3-inch piece of fuel line in a drill press chuck (*Figure 3*). Next, slide the fitting onto the fuel line (*Figure 4*). This will align the fitting hole 90 degrees to the drill press chuck.

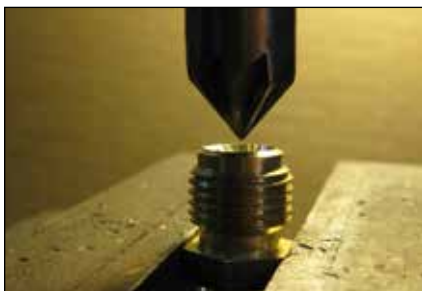
Figure 5

Clamp the fitting into a drill press vise and removed the fuel line from the drill chuck. Using a 1/2-inch diameter, 60-degree countersink (*Figure 5*), cut the fitting so the new ferrule will fit. These ferrules, which are very inexpensive, are available at hardware stores, auto parts stores, and plumbing shops. *Figure 6* shows the completed fitting.

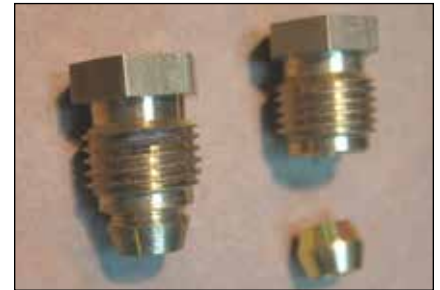
Figure 1

THE FUEL LINE FITTING to the fuel inlet housing is a source of very slow drips. I suspect it is due to the new, one-piece brass gas line fittings. The old-style fittings were two pieces, which would pinch the fuel line to help produce a leakless seal. *Figure 1* shows the old, two-piece fitting on the right and the new, one-piece fitting on the left.

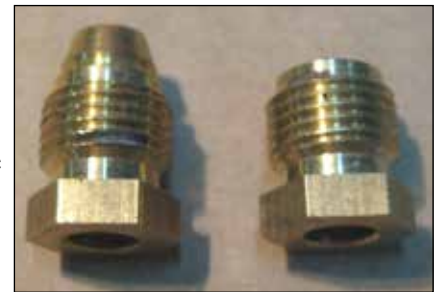
Figure 2

The solution to this problem is easy: make the one-piece fitting into a two-piece fitting. *Figure 2* shows the new fitting cut down. Basically, you cut off the ferrule.

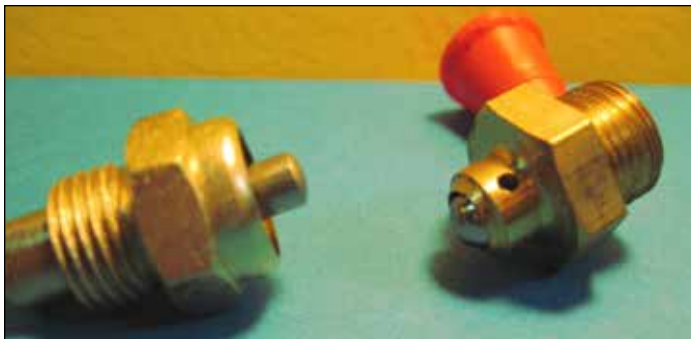
THE NEXT PROBLEM AREA is the float valve. *Figure 7* shows the original style valve on the left and the modern ball bearing valve on the right. The old style valve is a needle and seat. Though these have been improved with the Vitron seal design, a small speck of dirt can keep the valve from sealing.

Figure 7. The original style valve (left) and the modern ball bearing valve (right)

A better alternative, and my preferred fix, is to use a ball bearing valve. These

are known as the Grose Jet valves. These valves use two ball bearings, which are freewheeling, so a speck of dirt usually does not keep them from sealing.

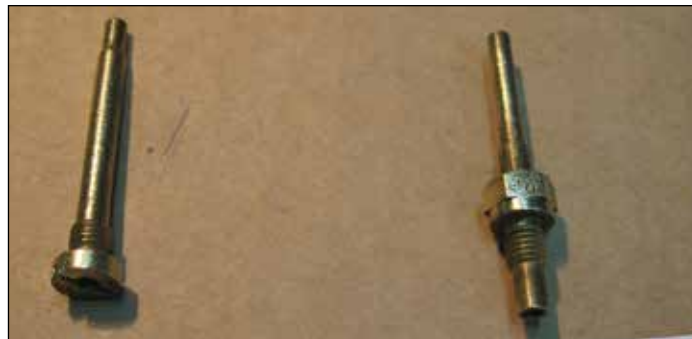
Figure 8. Main jet (left) and cap jet (right)

Too high a float setting will cause leakage from these jets. The main jet should be taller than the cap jet. **Figure 8** shows what the main jet and cap jet look like. The main jet sits vertical, and the cap jet sits at an angle.

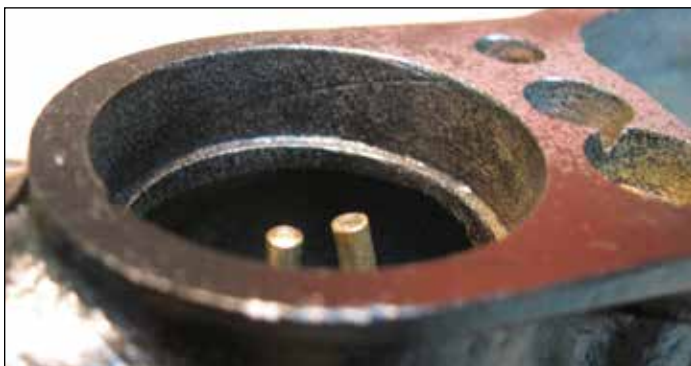
Figure 9. The cap jet stands taller than the main jet.

Figure 9 shows the cap jet taller than the main jet. Why is it taller? Two common reasons contribute to this

problem. One is if a reproduction jet is not manufactured to original Ford specifications. The other reason could be extra gaskets on the jet (**Figure 10**) or lodged inside the jet's threaded cavity.

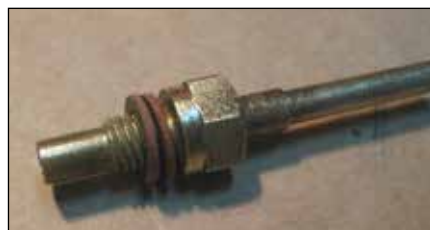
Figure 10. Jet with extra gasket.

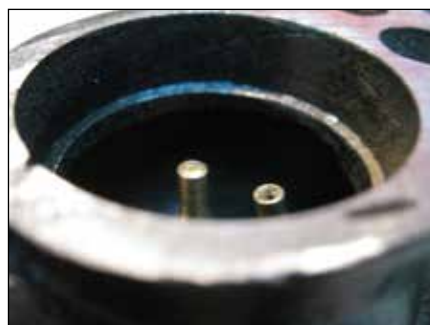
Figure 12. Main and cap jets installed correctly, with main jet taller.

Unlike reproduction jets, the original jets have a number stamped on the hex area (**Figure 11**). The main jet will measure 1.48 inches from the gasket area to the end of the jet. A cap jet will measure 1.115 inches from the top of the hex to the end of the jet. (Jets that are too short can siphon gasoline out of the float bowl.) **Figure 12** shows the main jet and cap jet correctly installed, with the main jet $\frac{1}{16}$ to $\frac{1}{32}$ inch taller.
