# Six Overlooked Problems on the Zenith Carburetor

*It pays to pay attention to detail*

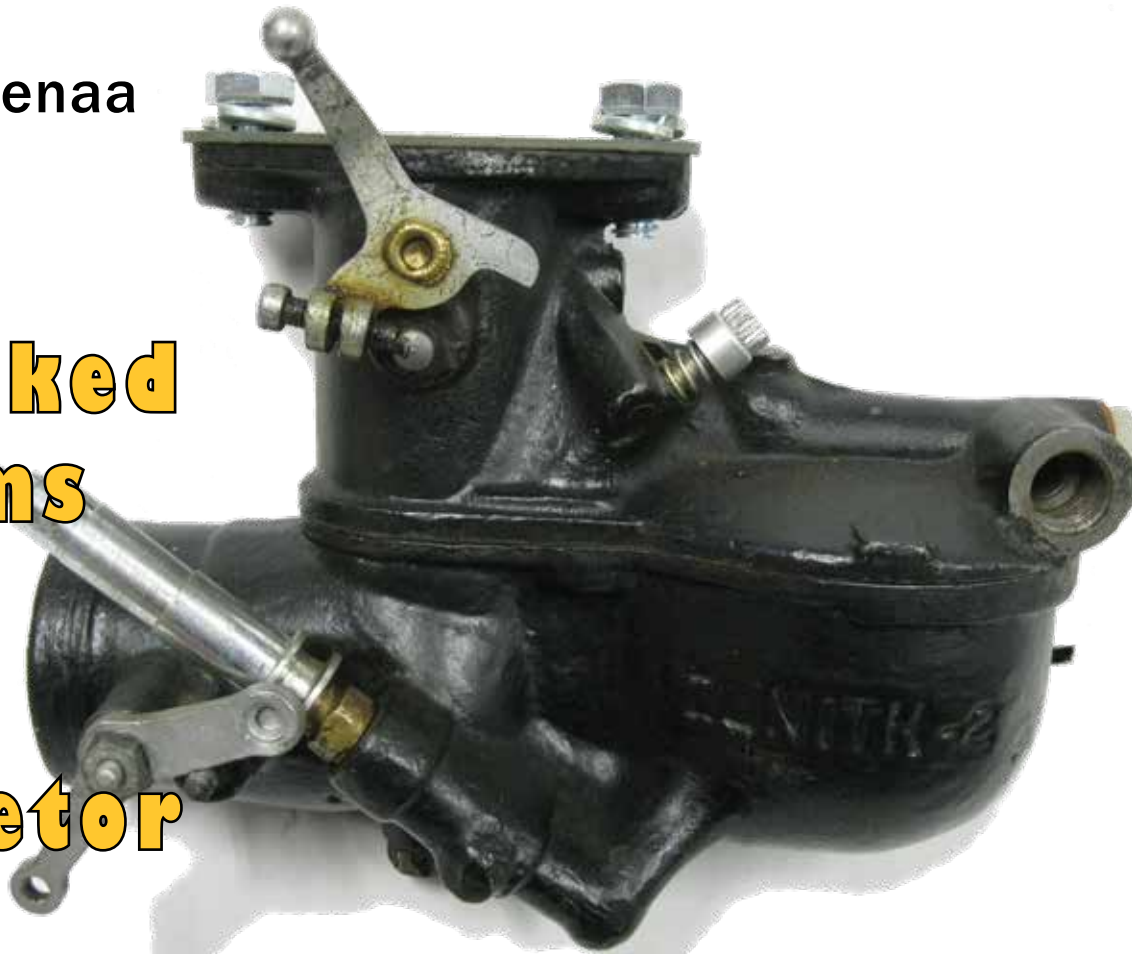
Figure 1

## 1. TWISTED FUEL STRAINER A-9559 (See figure 1.)

Why is a new fuel strainer twisted when installing? Is the reproduction part too long? No, it's due to the fact that the small, brass end had been broken off a previous strainer, thus taking up room. Figure 2 shows the small piece that was removed from the strainer housing.
